THE EFFECT OF AGING TIME

ON SPALLATION OF

2024-T6 ALUMINUM

AMMRC TR 71-61

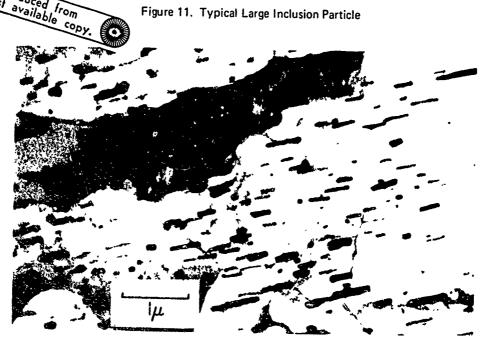
Figure 12. Set I Material Cut Longitudinal to the Rolling Direction Showing the Distribution of Dispersoid Particles and Subgrain Structure

0.5 to 1.0μ . Those smaller, noncoherent particles, sometimes called dispersoid particles, have been identified 11 as complex intermetallic compounds containing aluminum, manganese, magnesium, iron, and silicon. In a high purity Al-0.6% Mn alloy, they have been identified as Al₆Mn. The chief function in the alloy of those dispersoid particles appears to be the control of grain growth during the solution treatments which mainly affect the copper rich precipitate phase.

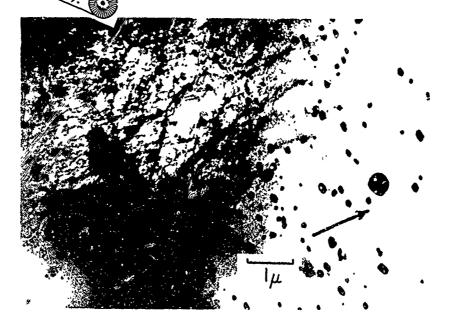
Figure 14 shows an area of set I material from specimen I-5 impacted by the mylar flyer plate at 2.3 mm/µsec. Extensive dislocation networks were observed, especially in the region of inclusion particles such as the one in the upper corner of Figure 14. The wave propagation direction, shown by the arrow in Figure 14, was roughly perpendicular to the long axis of the large inclusion particle. The dislocations appeared to form a braid or band structure which can be seen faming out from the end of the particle. Due to the presence of the hardening precipitate and the dispersoid particles, dislocations were not mobile enough to move under the influence of the heating from the electron beam to provide surface slip traces. Without slip traces, accurate foil thickness determinations are difficult and, hence, no attempt to determine dislocation densities was made.

Figure 14. Set I Material (Spr. simen I-5 Impacted at 2.3 mm/µsec) — A High Density Distriction Structure Was Observed in the Vicinity of Inclusions Such As the One Shovin

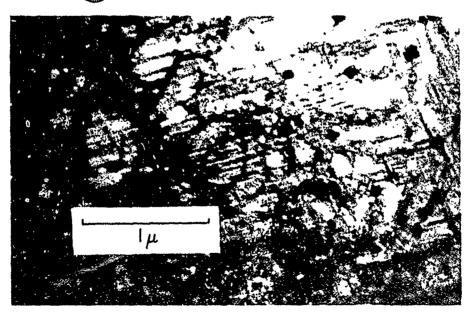
Figure 16 shows set III overaged material after impulse loading by the flyer plate at 2.3 mm/ μ sec. In addition to the S phase laths, a loosely defined dislocation cell structure is present with a cell size of approximately 1μ . Although no dislocation densities were measured, it appeared that the most dislocations were retained in shocked set I material.

Figure 16. Set III Material (Specimen III-5 Impacted at 2.3 mm/µsec) — Moderate Density Dislocation Nets Form a Loose Cell Structure
